# OPTIMIZATION AND SCALE-UP TESTING OF COMPOSITE REPAIR TECHNOLOGIES

**Brad Whelan**

Engineering Project Manager – US and Canada

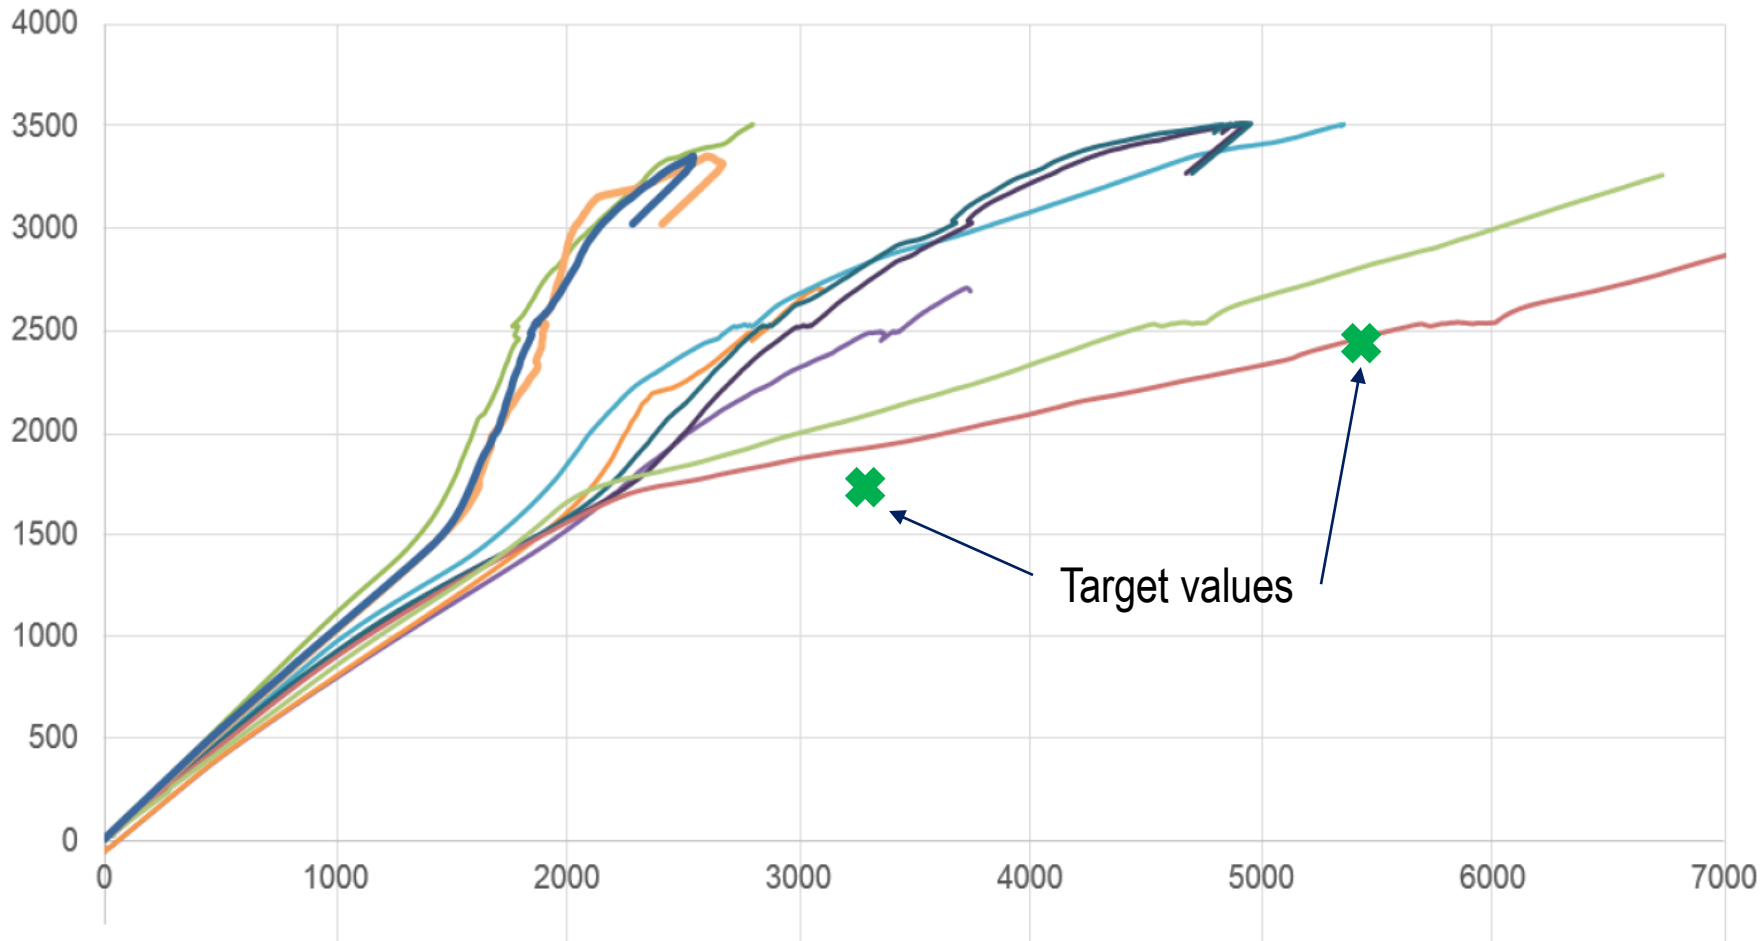
# PRESSURE TEST RESULTS

- ◆ Failure pressures noted were all similar in value (*within 4% of the average of all tests*)
- ◆ Nothing conclusive given by the burst pressure burst therefore emphasizing the importance of collecting strain data
- ◆ Determine and rank burst performance for each sample according to strain

- ◆ For strain data, benchmark targets set based on existing testing from PRCI
  - 3,200 microstrain at MAOP
  - 5,400 microstrain at SMYS
- ◆ Based on the strain readings, all repairs exceeded targets
- ◆ One sample clearly stood out and appears to be the 'best' overall performer
