Common Applications for Acoustic Emission Testing (AET)

STEVEN GARCIA, PRINCIPAL

An Overview of the Presentation

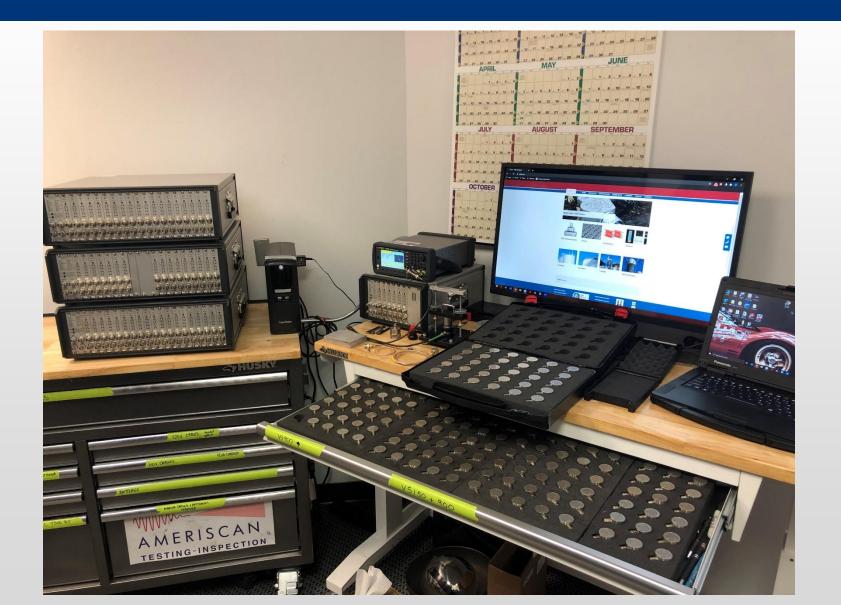
Vallen Digital System AMSY-6

AE Technology – Hardware

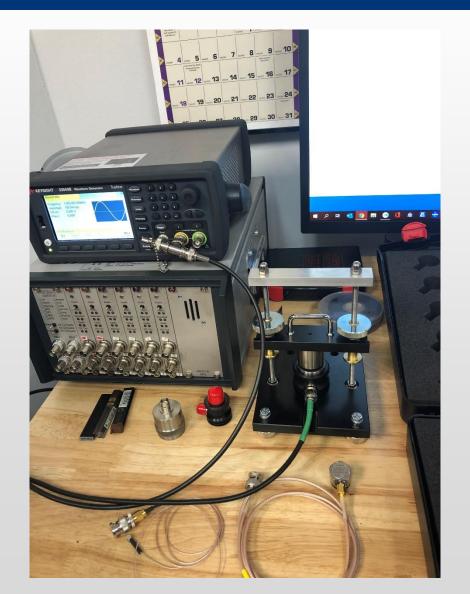
Arbitrary
Waveform
Generator,
AMSY-6 Chassis,
and Sensor
Verification
Fixture

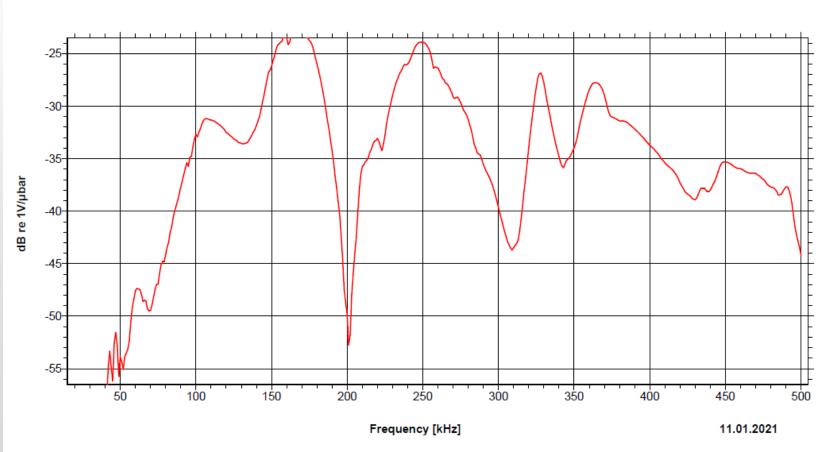
VS150-RIC14654

Sensor Verification Test Output

This diagram shows the frequency response of the sensor under test in a face-to-face measurement setup. Method based on ASTM standard E976.

Excitation: 0.1 Vrms at V103 (50 Ω), Offset -114 dB,

coupling agent: light machine oil. For sensitivity to ANSI S1.2-1988, subtract 15 dB.

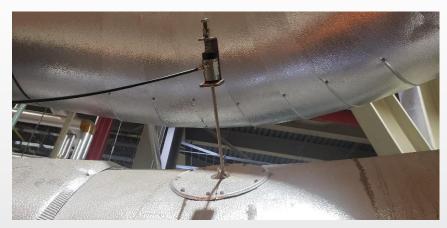
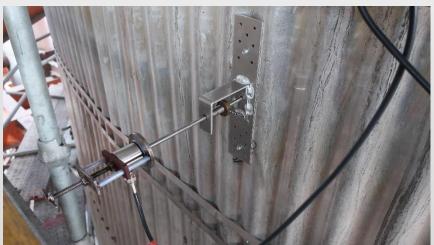
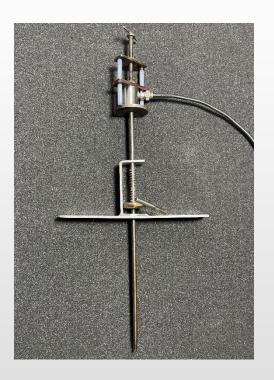
AE Technology – What are Waveguides? Why use them?

Temperature > 200 °F

1/4" Hole in lagging

1/4" Hole in insulation

Attach to lagging

Adjust collar against spring

Allow operators to couple the sensors to high or low temperature materials without damaging the sensor

Waveguides are typically 12-14" long unless the structure is exceptionally hot or covered by thick insulation

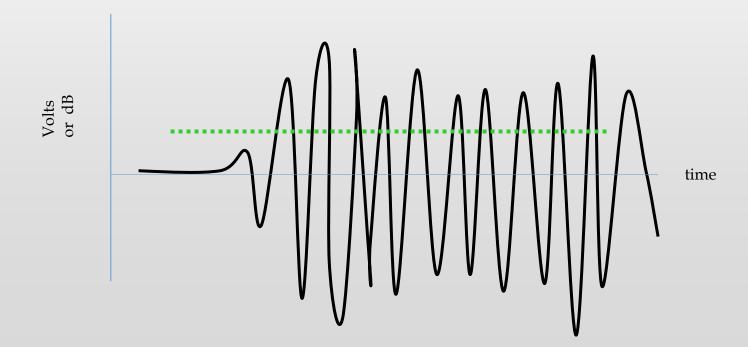
Continuous Emissions – Commonly used for leak testing applications

- Typically measured as RMS (Root Mean Square) Voltage or
- ASL (Average Signal Level) in dB

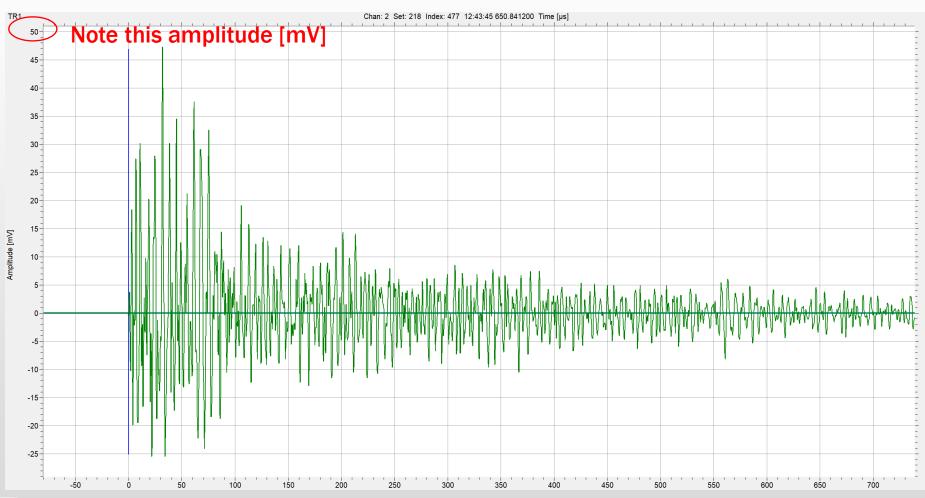
Example of a Fiber Break in a FRP Vessel

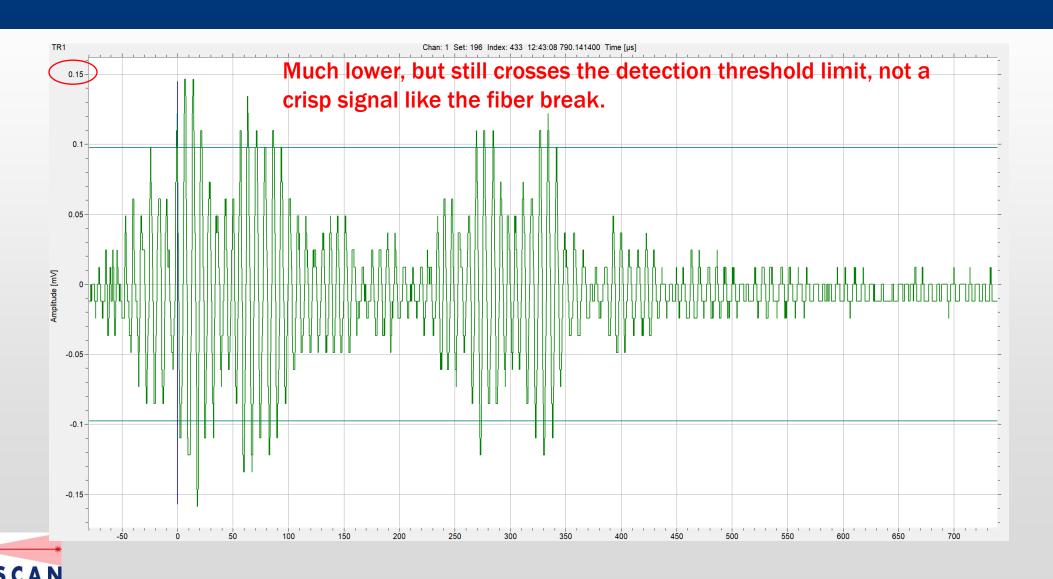
"Noise" i.e. part movement, rubbing, process, etc.

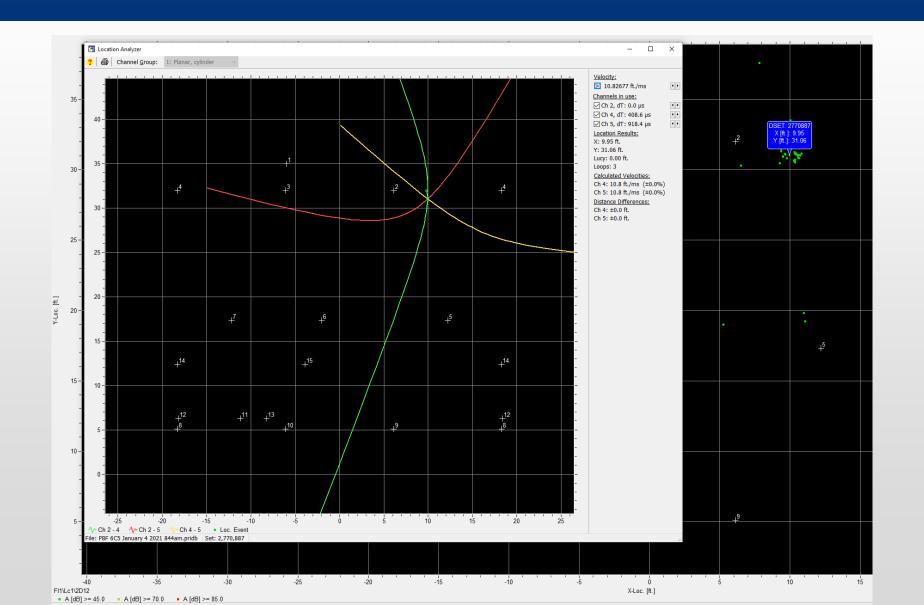
Location Processor – Lightly Filtered Data

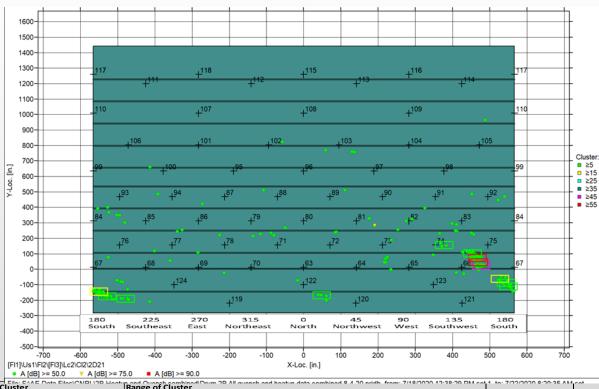
Example Data from a Pressure Vessel

The recorded data is filtered to eliminate erroneous emissions and a cluster analysis is performed.

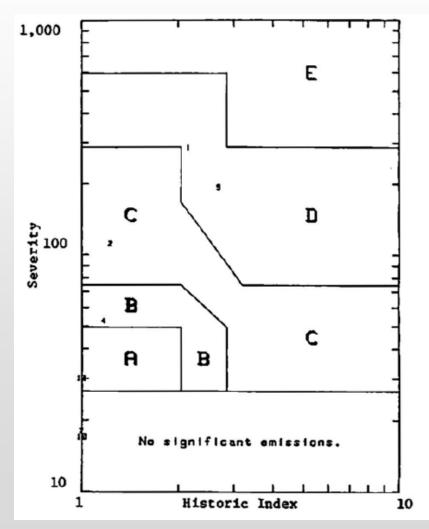
Example of a Zonal Intensity Plot (ZIP) Used for Intensity Analysis

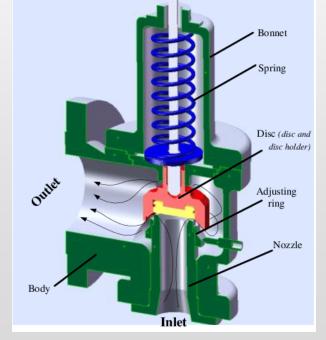
A single sensor (400KHz or broadband) is mounted to the valve body via a magnetic holddown, tape, etc.

The acoustic emissions were monitored for approximately 10 minutes per valve

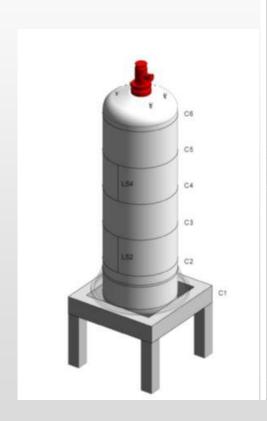
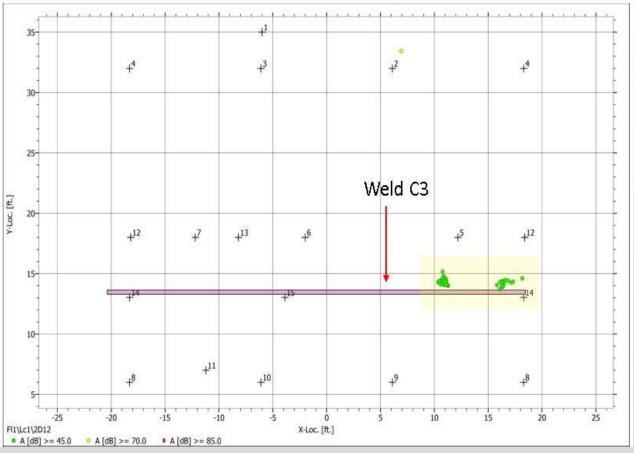
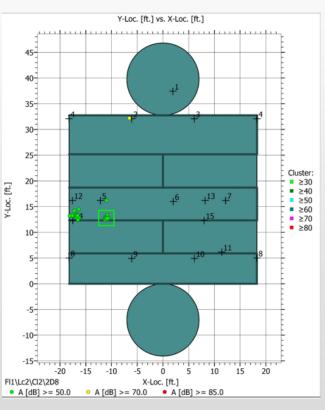
Acoustic Emission Data

- Initial online AE test revealed activity near a circumferential weld seam/heat-affected zone. High concern for potential HTHA damage due to age/process/material.
- Reactor skin temp made it difficult for other NDE methods.
- Long-term AE monitoring was suggested in lieu of shutdown.
- Process upsets during monitoring caused rapid thermal gradients, which caused high-amplitude AE activity in ares of concern.

- Plant Management requested maintaining online AE for extended period until replacement reactor was available.
- New reactor was designed with 2-1/4 chrome material and ordered for fabrication.
- Process controls put in place to maintain temp below 600 F to prevent damaging excursions.
- Client able to maintain critical operations uninterrupted.
- Continuous AE monitoring has been in place for over 3 years.
- Managed remotely via cellular connection.

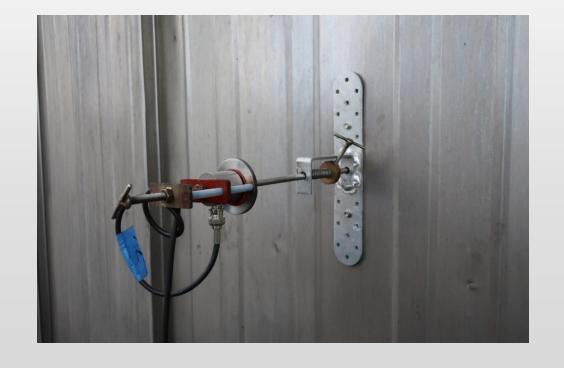
AE Used to Detect Problem Areas for Follow-up

- Multiple AE sensors installed by a rope access crew for all 6 drums.
- Monitoring took place during normal coking cycles.
- Waveguides used to minimize insulation disturbance and protect sensor from surface temp.
- Data collection equipment mounted on skirt deck to minimize cable lengths.

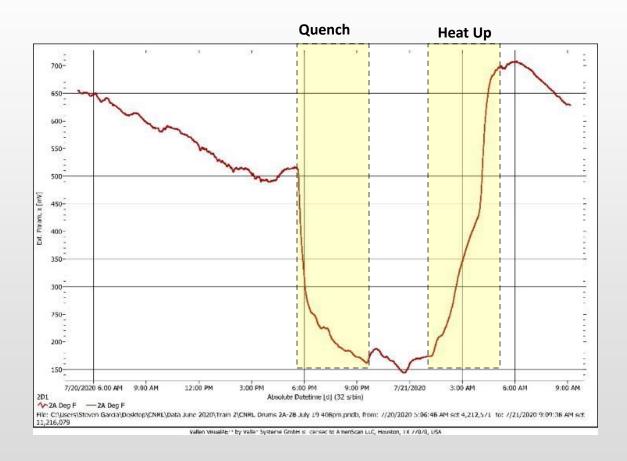
Acoustic Emission Data

- Only data during the quench and heat-up portions of the cycle were used for data analysis.
- Thermal gradients during these periods are most damaging and cause the most cumulative damage.

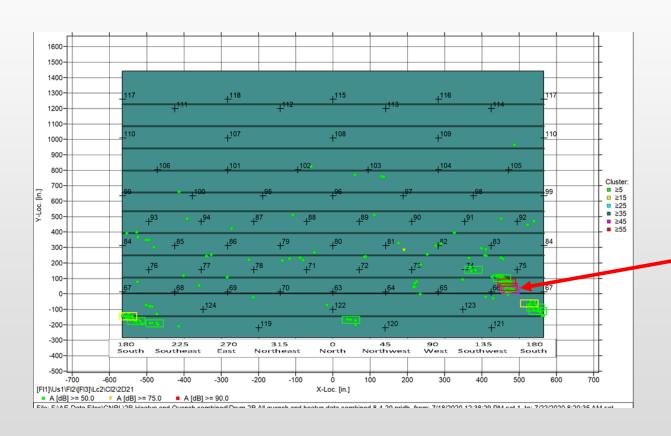
Acoustic Emission Data Cont.

Several areas identified, but most severe area highlighted based on repeated AE activity during multiple cycles at same location.

- Multiple AE sensors were installed to cover entire drum
- All drums tested with no incidents and within time-frame requested by client.
- No scaffolding required, saved client significant money.
- Most problematic area of bulge near weld seam identified with confirmed crack after PAUT.
- AE data correlated well with laser scans and engineering assessment.

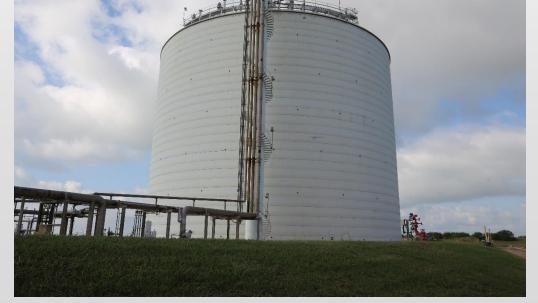
Methanol/Alcohol used to mitigate ice formation during sensor installation.

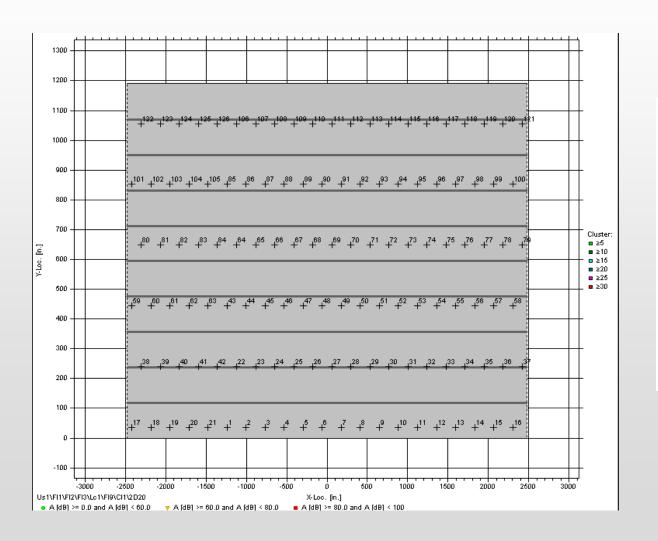
Acoustic Emission Data

- No locatable AE data from propagating flaws due to ammonia SCC were observed during the fill test.
- Client resumed tank operation until next inspection interval.

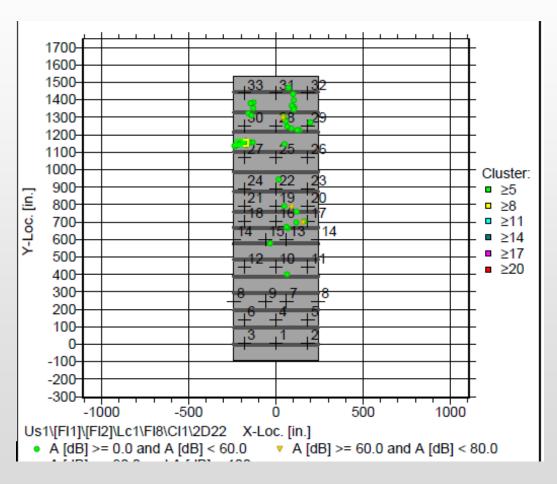
Acoustic Emission Data

- Multiple AE sensors installed for complete coverage.
- AE testing took place during pneumatic overpressure test.
- Locatable AE data was observed during the pneumatic test and reported.
- Recommended to the client to follow-up in the specific areas noted using conventional NDT.

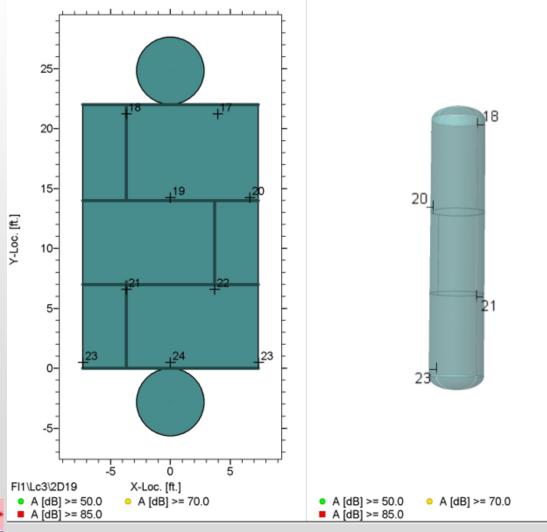
Acoustic Emission Setup

- Multiple sensors installed per vessel to obtain 100% coverage.
- Waveguides used to minimize insulation disturbance and protect sensor from surface temp.
- Wireless connection for 24/7 monitoring.
- Data alarms used to alert power failures and data activity.

- Multiple AE sensors were installed on each vessel to provide 100% coverage.
- Remote monitoring system installed with wireless access to AE monitoring system and data.
- Alerts for any AE activity sent via text messages.
- Managed 24/7 from Houston office with no personnel in the unit.
- Client continued normal operations for 11 months with no incidents of failure while new vessels were fabricated for replacement.
